BUILDING INSPECTION REPORT

**60 Merrick Way
Coral Gables, FL 33134**

**City of Coral Gables
Mrs. Zeida Sardinas**

August 15, 2022

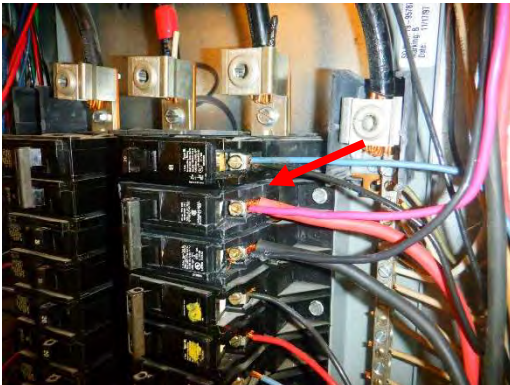
1. Panel B:
 - a. Double-tap breakers observed inside the breaker panel.
 - b. Double-tap lugs observed at the feeder lug connection.
 - c. Missing knockout cover plates observed.
2. Outlet near the prep station sink is not GFCI rated.
3. Light fixture inside the kitchen sink cleaning area is inoperable.
4. One (1) light fixture inside the men's restroom is inoperable.
5. Exit light above the main entrance is improperly wired.
6. Exit light above the south entrance is inoperable.

Double-Tap Breaker

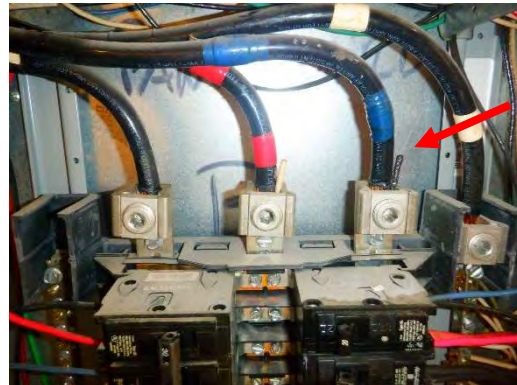
Double-Tap Lug

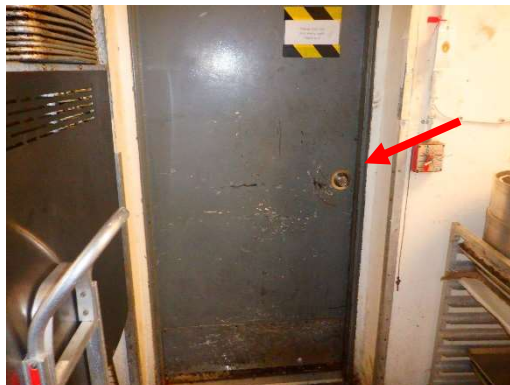
1. Front north bottom window panel is defective. Defective air gasket was observed. The formation of a foggy like image was observed at the bottom of the window.
2. Egress kitchen door hardware has incorrect unsafe type of egress door hardware. No panic hardware was noted.
3. Handicap partition wall inside the men's restroom is not properly secured. Wall mounted on the door is substandard.
4. Door leading to the women and men restroom is not installed. Door appears to have been removed from the door frame.

Incorrect Egress Hardware

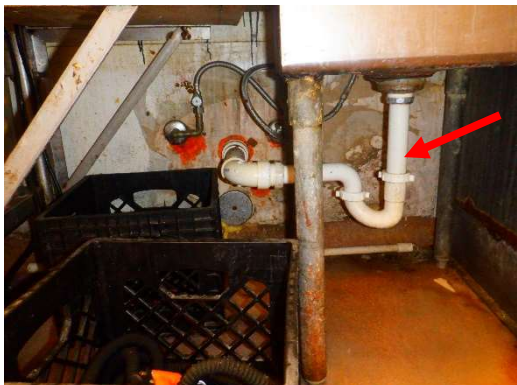
1. Interior wall for partitions housing merchandise is incomplete. Studs are exposed. Construction of the shelving of merchandise appears to be substandard. We recommend removing the partition.
2. Moisture damage observed below the prep station sink. Hidden moisture damage may exist.
3. Moisture damage observed and modifications noted to the wall below the dishwashing station/sink. Hidden moisture damage to interior wall cavity may exist.

Moisture Damage

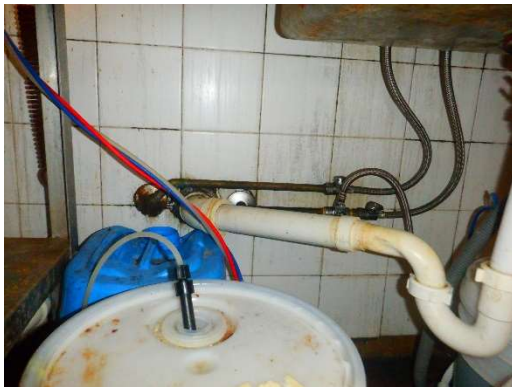
Water Plumbing

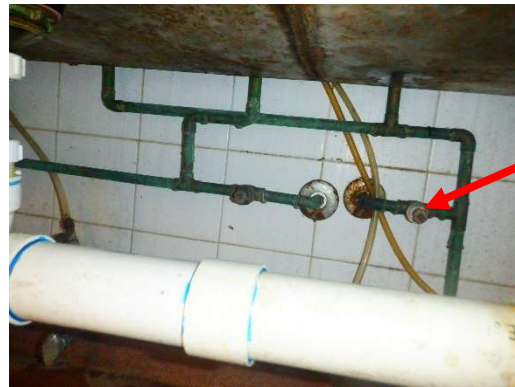
1. Office manager bathroom sink is cracked.
2. Active water leak observed below the kitchen sink.
3. Kitchen sink water stem valves for the hot and cold-water valves are missing.
4. Men's Restroom:
 - a. Wall mounted urinal is cracked.
 - b. Wall mounted sink is not properly security.
 - c. Handicap bathroom sink is cracked.
5. Women's Restroom:
 - a. Toilet is loose at the base.
 - b. Overflow plumbing line below the handicap bathroom sink is not connected.

Missing Stem Valve Handles

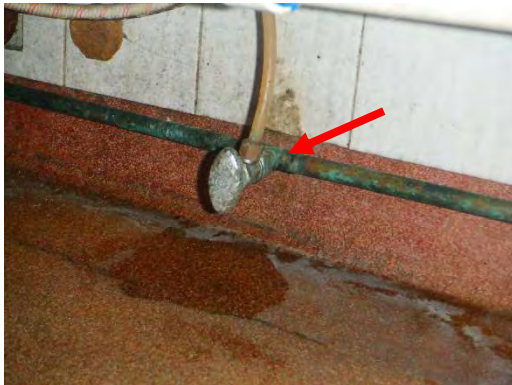
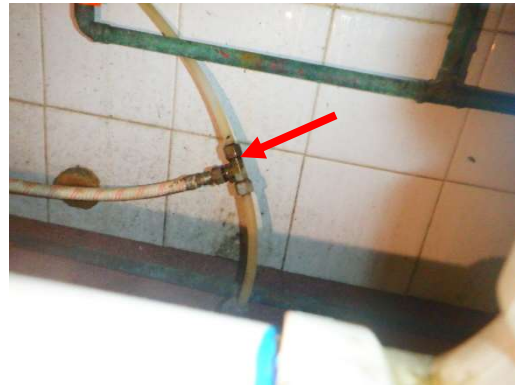
Water Leak Below Sink

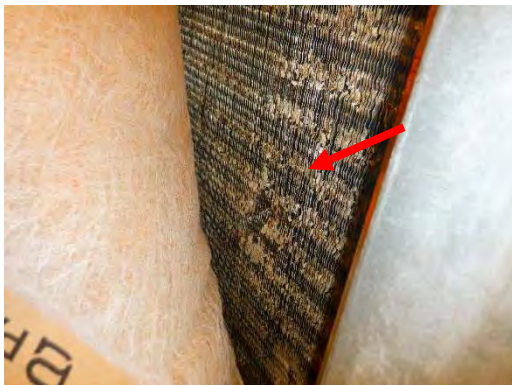
1. Unit # 1: Unit coils are brittle. We recommend monitoring performance of the equipment.
2. Unit # 2: Unit coils are brittle and damaged. Fins are bent.
3. Unit # 3: Unit coils fins are bent and bottom controls access cover plate is not properly secured. We recommend monitoring performance of equipment.
4. Cooling Tower # 1:
 - A. Exterior FRP casing vents are deteriorated and brittle. The south sector of the cooling tower vents is damaged.
 - B. Casing filler screens are brittle and packed with overgrown mildew. These conditions effect the flow of air and water.
 - C. Casing supporter and anchors are show signs of heavy corrosion.
 - D. The ladder mounted on the side of the equipment is heavily corroded. Unsafe to climb.
 - E. The interior of the equipment was not visible due to the high levels of algae growth.

Brittle Heat Pump Coils

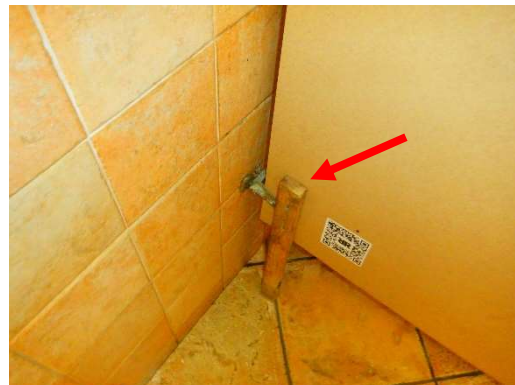
Bathroom Partition Not Secured

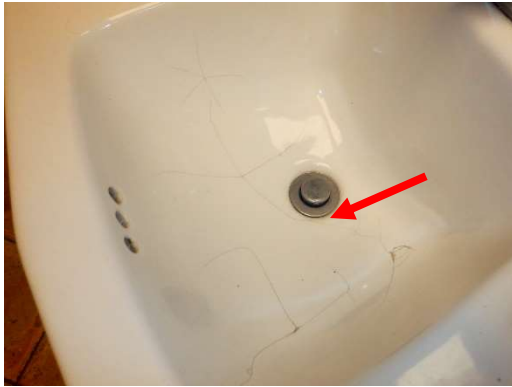
Cracked Bathroom Sink

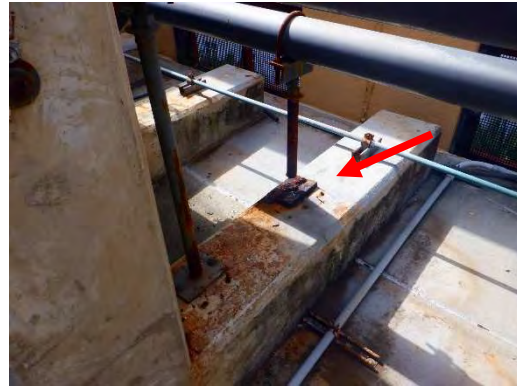
- A. Water shutter valves are corroded. Valve handle is missing.
- B. Bottom of the FRP tank is cracked.
- C. Chill water line pipe stands and bases are corroded to the point of replacement.
- D. Exterior FRP casing vents are deteriorated and brittle. The south sector of the cooling tower vents is damaged.
- E. Casing filler screens are brittle and packed with overgrown mildew. These conditions effect the flow of air and water.
- F. Casing supporter and anchors are show signs of heavy corrosion.
- G. The ladder mounted on the side of the equipment is heavily corroded. Unsafe to climb.
- H. The interior of the equipment was not visible due to the high levels of algae growth.

Corroded Pipe Stands

6. Due to the above deficiencies and lack of preventative maintenance to equipment, we recommend client budget and plan for replacement, in lieu of repairs.

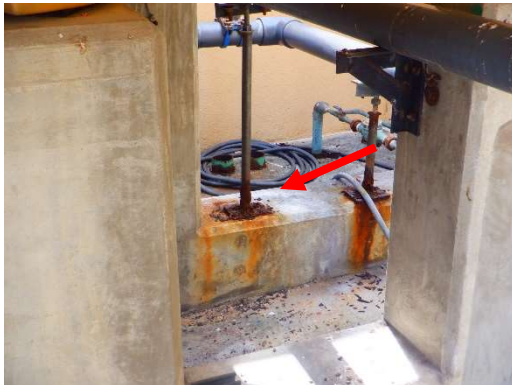
Corroded Pipe Hangers

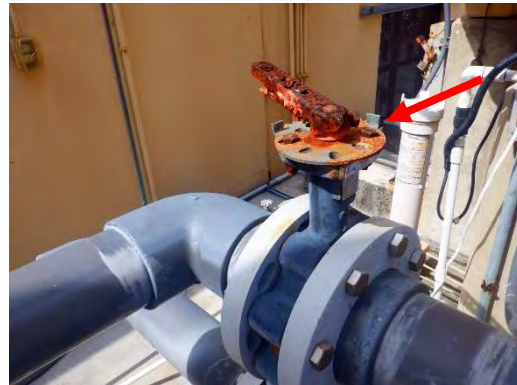
Corroded Water Valves

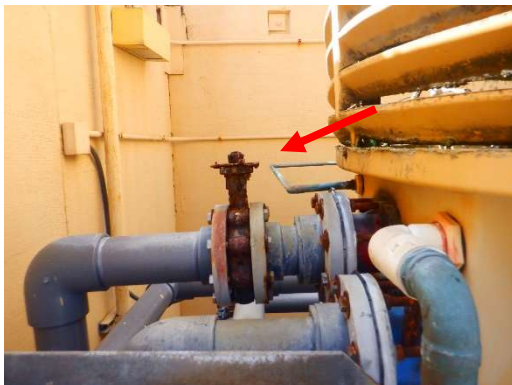
Corroded Valve Handles

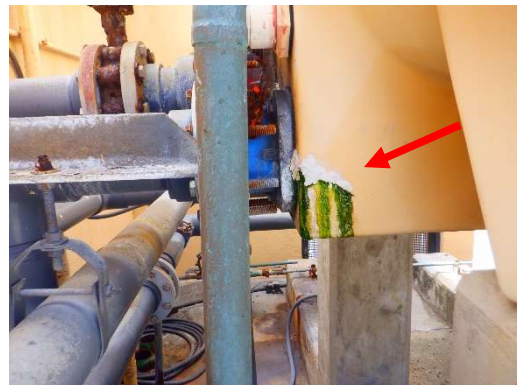
Crack Bottom of Chiller Housing

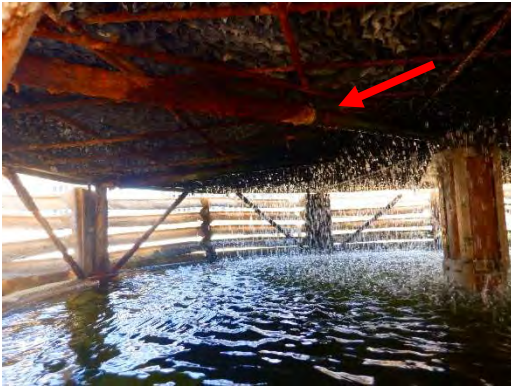
Excessive Mildew

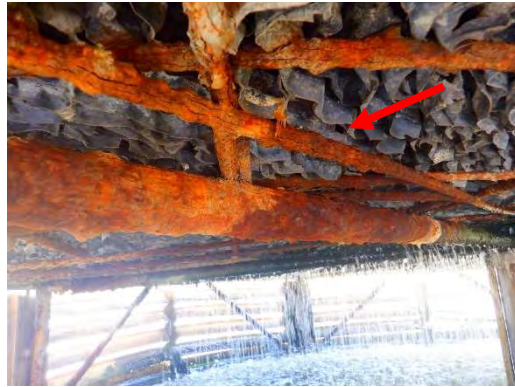
Corroded Pipe and Frame

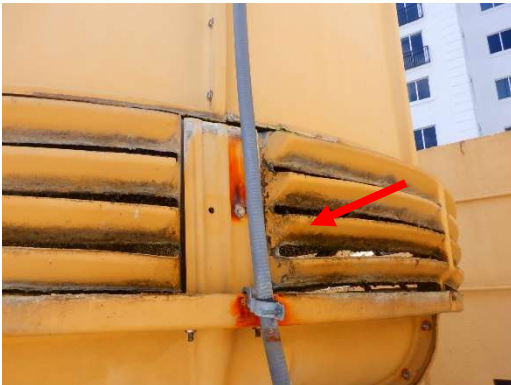
Brittle Housing

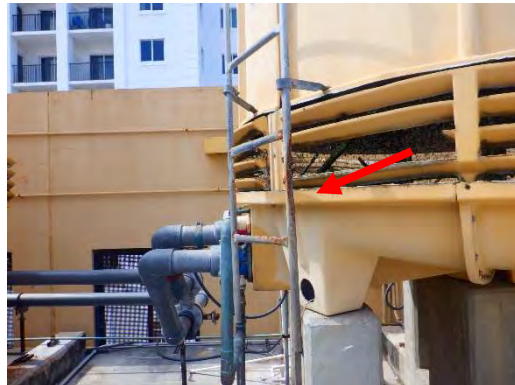
Corroded Ladder

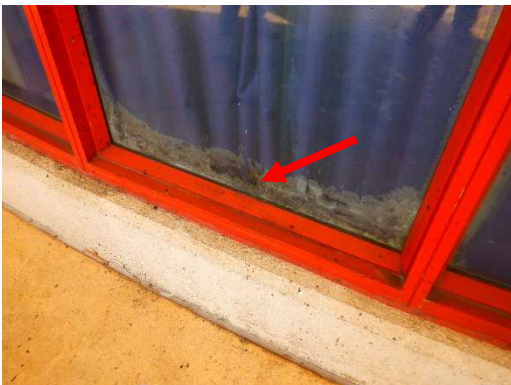
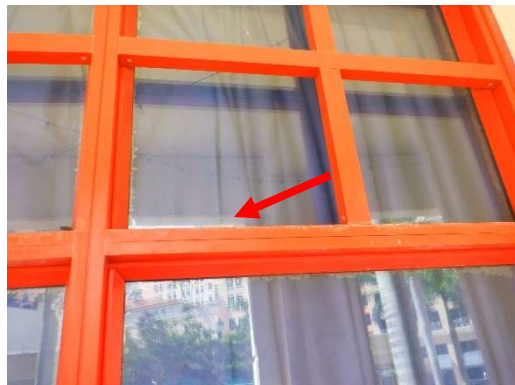
Fog Between Window
