7.5.2 PREVENTATIVE MAINTENANCE PLAN NARRATIVE

**CITY OF CORAL GABLES
COMMUNITY RECREATION DEPARTMENT
War Memorial Youth Center
ADMINISTRATIVE REGULATION**

Preventative Maintenance Plan

City of Coral Gables Community Recreation PLAYGROUND & PARKS MAINTENANCE & SAFETY INSPECTION CHECKLIST FORM

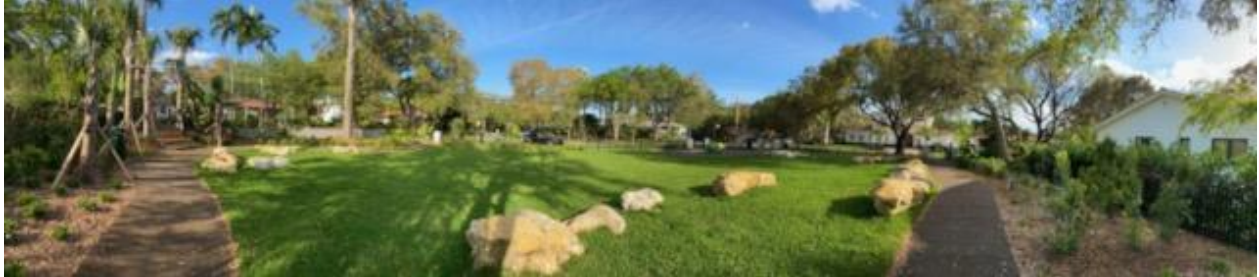
Image 1. Panoramic view of new park & playground appropriate for ages 2-5

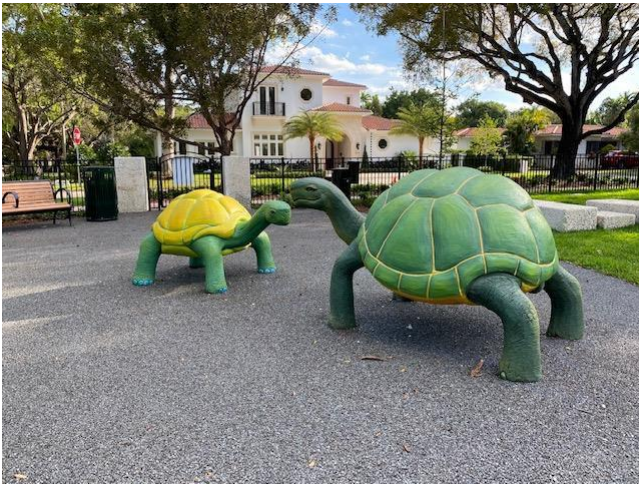
Due to missing safety surfacing (considered a critical safety violation) the playground inspection has not passed and the park is unable to open until corrective action is taken. Playground use zones are compliant as per manufacturer. Impact attenuation surfacing testing must be provided. Adequate age appropriate rule signage is missing and must be clearly visible to public users. See attached images.

Image 2. Play components with safety surfacing missing age appropriate signage.

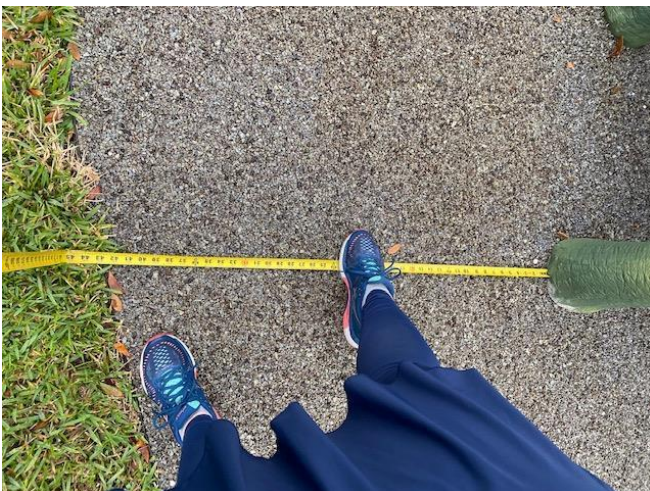
Image 4. Distance between play sculpture and safety surfacing edge is approximately 2.5ft and must be corrected to meet a minimum of 6ft of safety surfacing around the entire play sculpture.

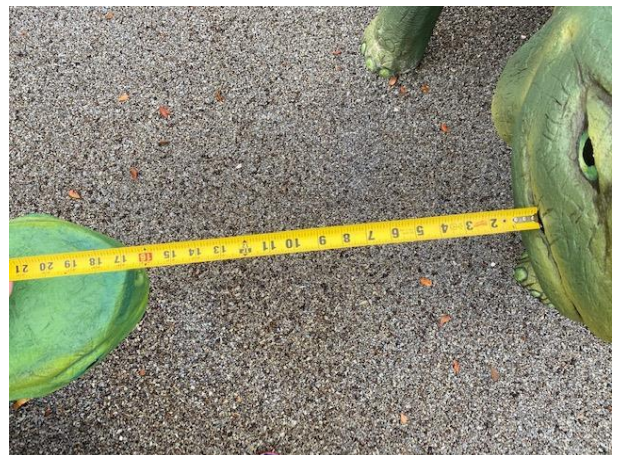
Image 3. Use zone and separation between both turtles is 16 inches and therefore considered functionally linked.

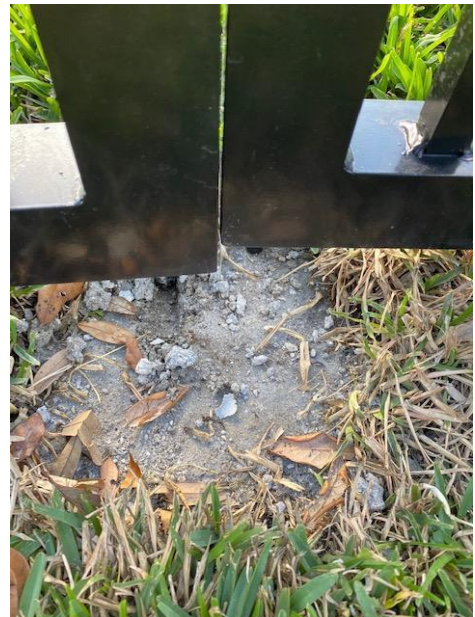
Image 5. Service entrance missing sleeve for gate peg.

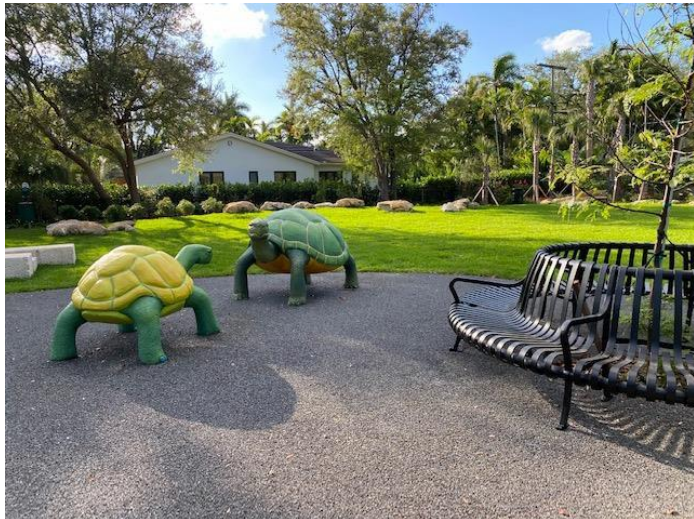
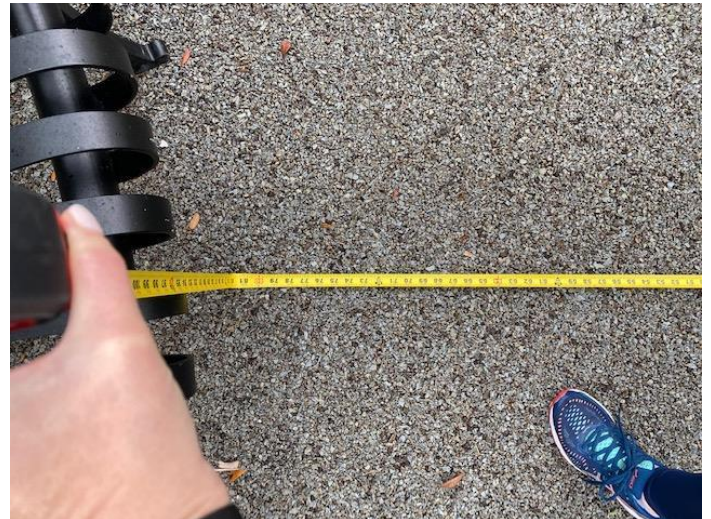
Images 6 & 7. Use zone is clear of any structures or furnishings. The circular bench is compliant and 6ft from the play sculpture.

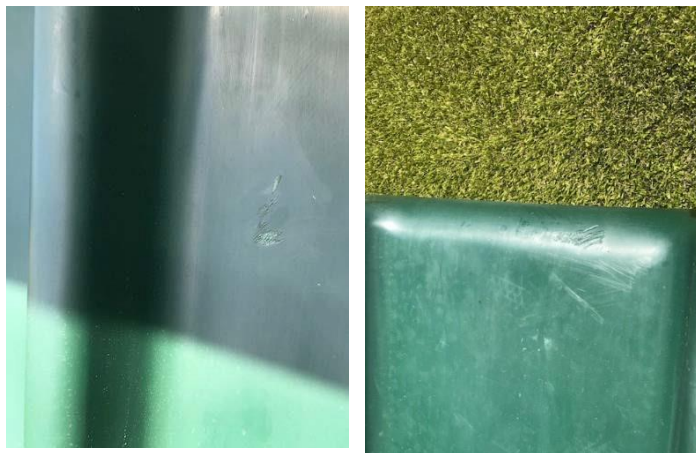
Playground use zones are compliant and impact attenuation surfacing was provided under all play equipment. Damages (scratches) were noted on the 2-5 composite play structure slide and climbing wall. A potential head entrapment hazard was identified in the 5-12 composite play structure. It appears that a beveled 2nd story panel was used on the ground floor that allows for two partial gaps that exceed 3.5in. A back panel should be added on the 2-5 composite structure steps. See attached images.

Images 2 & 3. Damages to slide on 2-5 structure

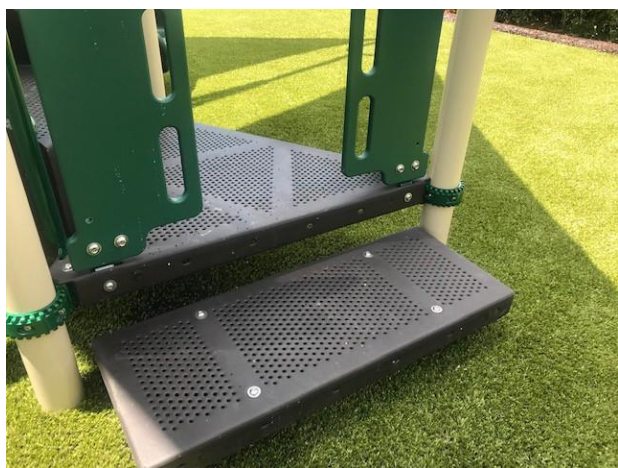
Image 4. Missing back panel on 2-5 entry steps

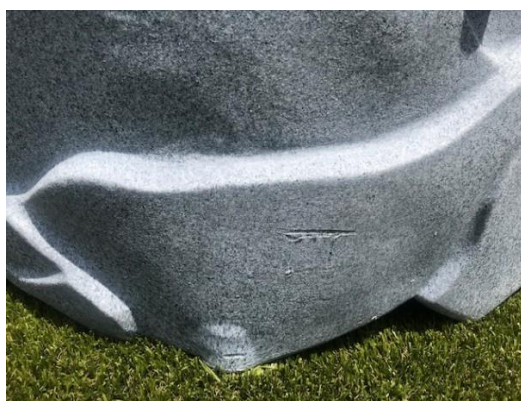
Image 7. Damages to climbing wall

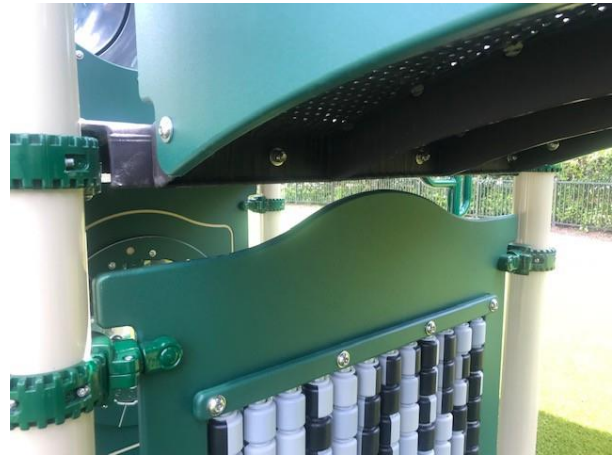
Image 9. Potential head entrapment hazard on bottom play panel – gap exceeds 3.5in on either side and is enclosed by support posts

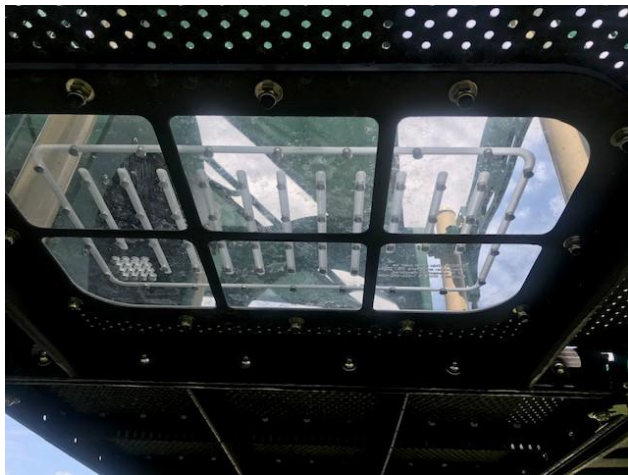
Image 10. Clear Plexiglas 2nd story support panel has an expiration date that should be noted for future replacement

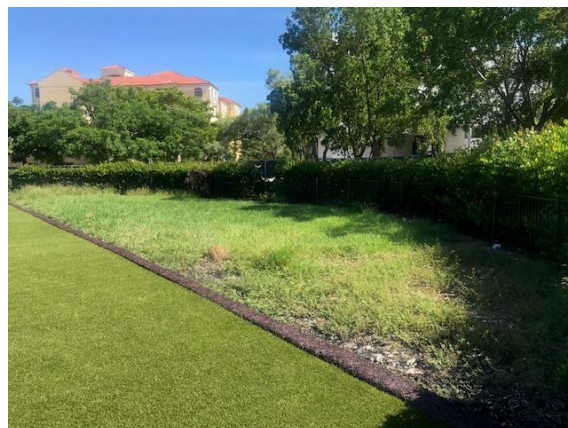
- ☒ The entire play area has satisfactory drainage, especially in heavy use areas such as under swings and at slide exits.
☐ Improve drainage It was noted by the artificial turf installer that there were drainage issues following a heavy rainstorm. Additional drainage holes were added by the GC to the unitary rubberized curbing to allow for additional drainage. Another inspection should be conducted following the next heavy rainfall to confirm adequate drainage.
☒ Other maintenance: _____

Image 12. Potential drainage concern with standing water remaining behind unitary rubberized curbing. Drainage holes were added to the border surrounding the artificial turf safety surfacing but should be tested for standing water during next heavy rainfall. Standing water may affect the impact attenuation of the safety surfacing.

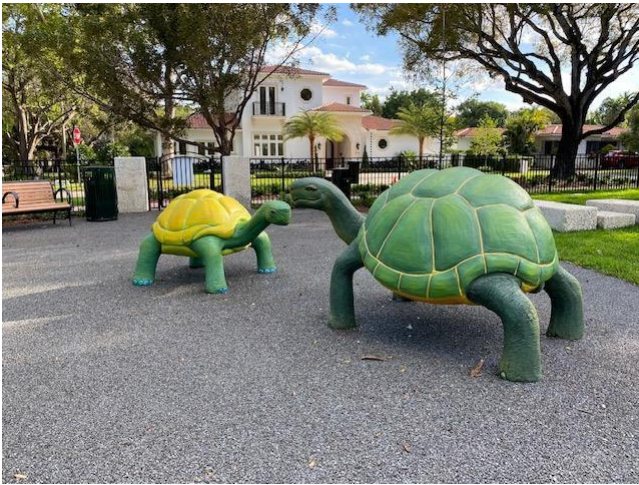
Due to missing safety surfacing (considered a critical safety violation) the playground inspection has not passed and the park is unable to open until corrective action is taken. Playground use zones are compliant as per manufacturer. Impact attenuation surfacing testing must be provided. Adequate age appropriate rule signage is missing and must be clearly visible to public users. See attached images.

Image 2. Play components with safety surfacing missing age appropriate signage.

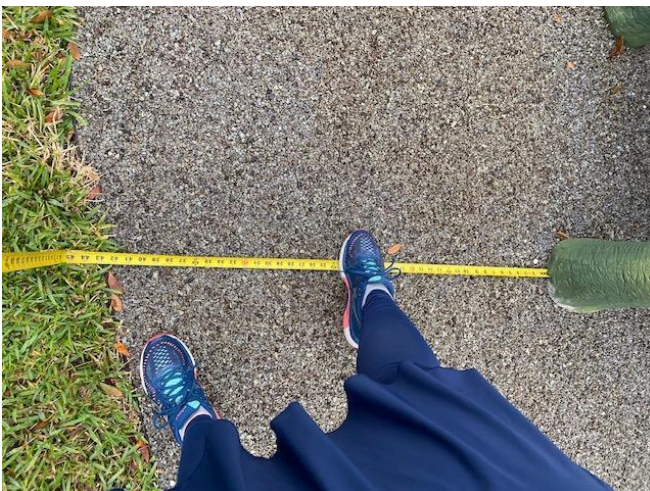
Image 4. Distance between play sculpture and safety surfacing edge is approximately 2.5ft and must be corrected to meet a minimum of 6ft of safety surfacing around the entire play sculpture.

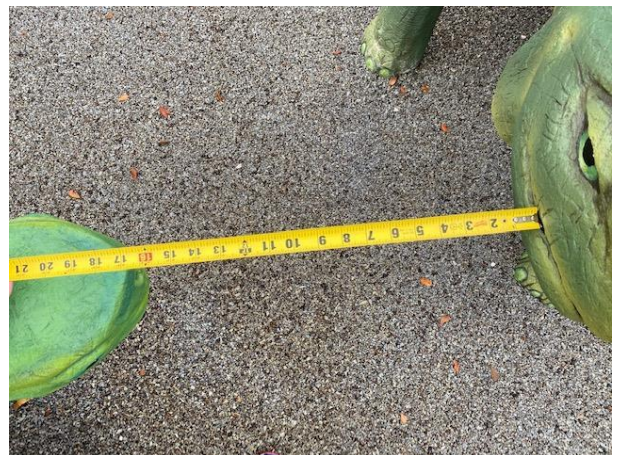
Image 3. Use zone and separation between both turtles is 16 inches and therefore considered functionally linked.

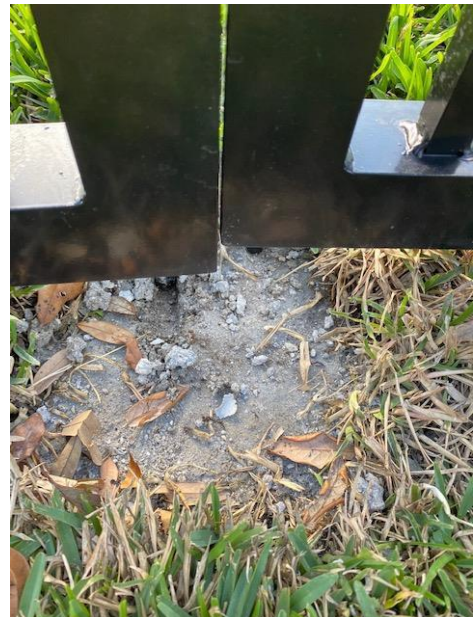
Image 5. Service entrance missing sleeve for gate peg.

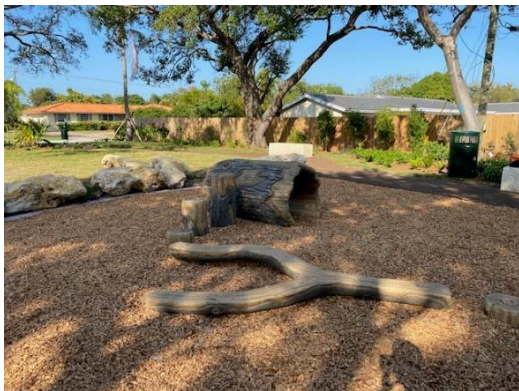
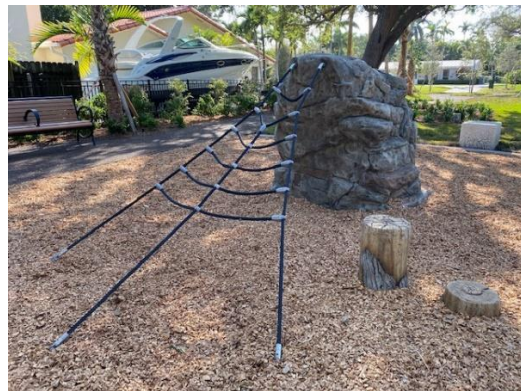
Images 2 & 3. Play components with safety surfacing missing age appropriate signage. Ages 2-5 for log and steppers and ages 5-12 for climbing net with large rock.

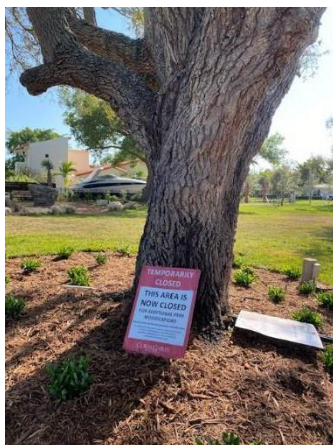
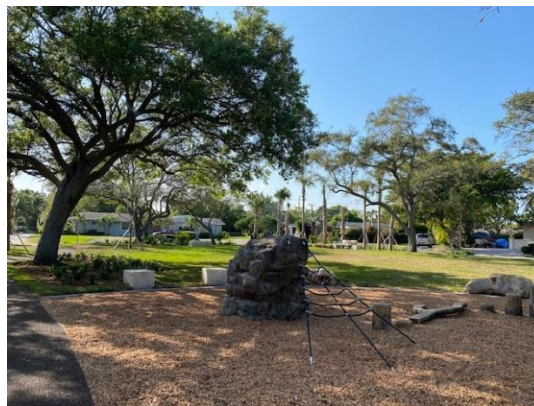
Image 4. Closure signage must be clearly visible until park is ready to open as this park cannot be secured by gates and fencing.

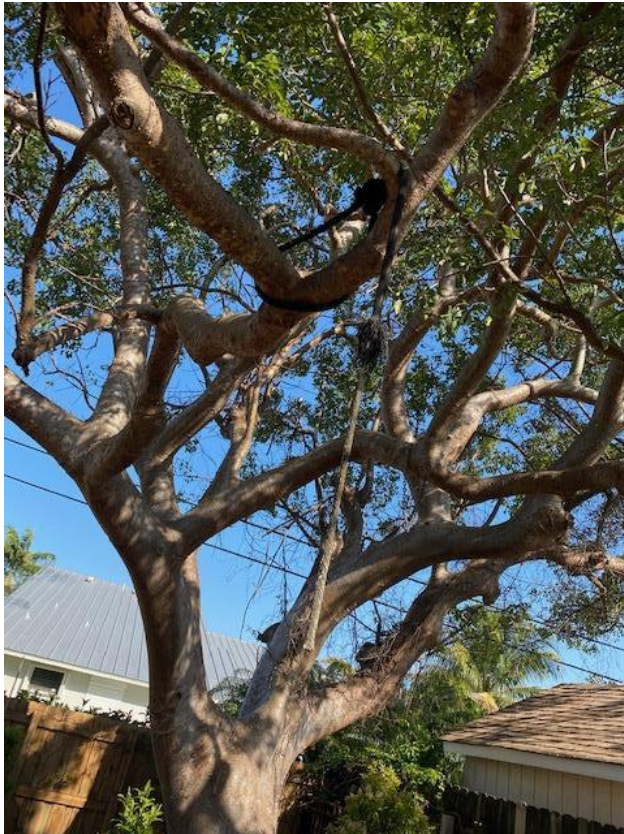
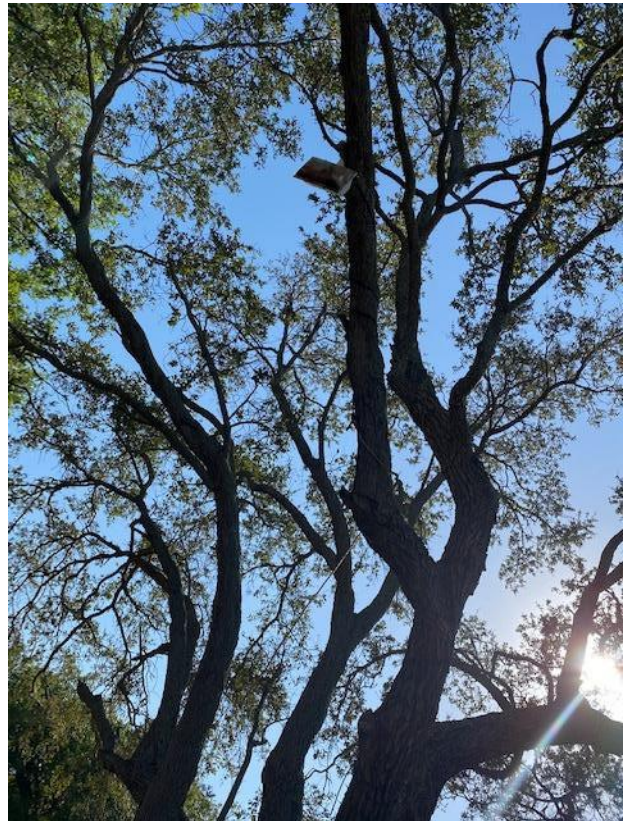
Images 7 & 8. Old rope and hanging light strings from trees must be removed for safety.

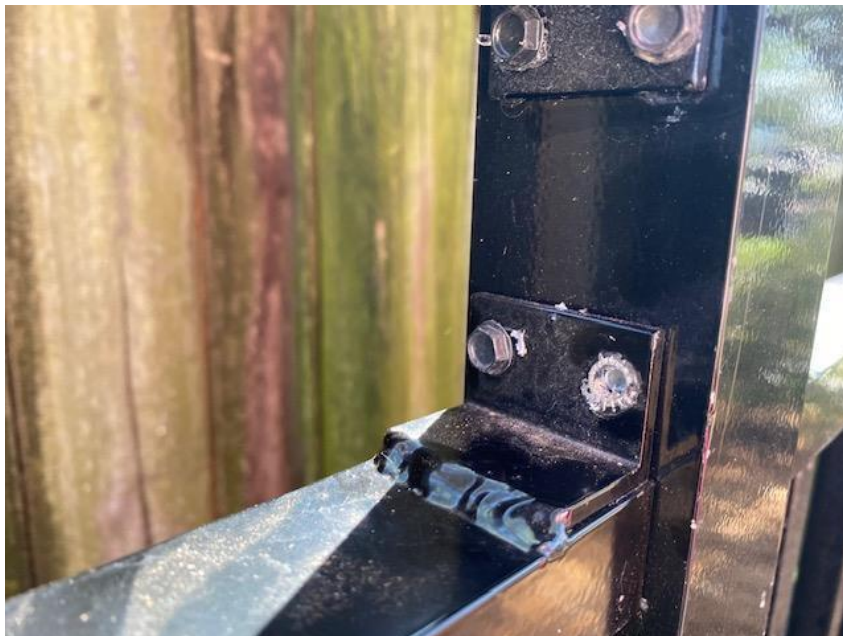
Image 9. Touch up work must be done to perimeter fencing on back for broken screws and etc.

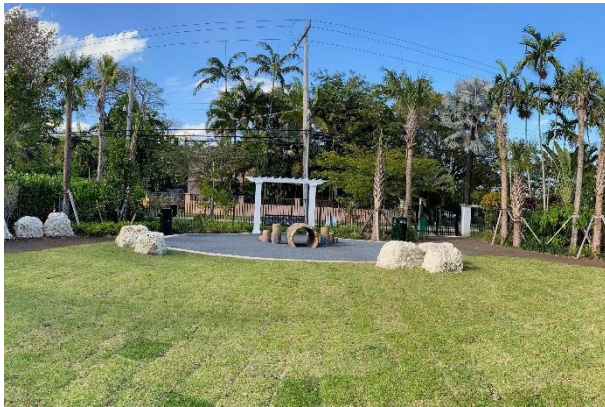
Image 2. Play components with safety surfacing missing age appropriate signage.

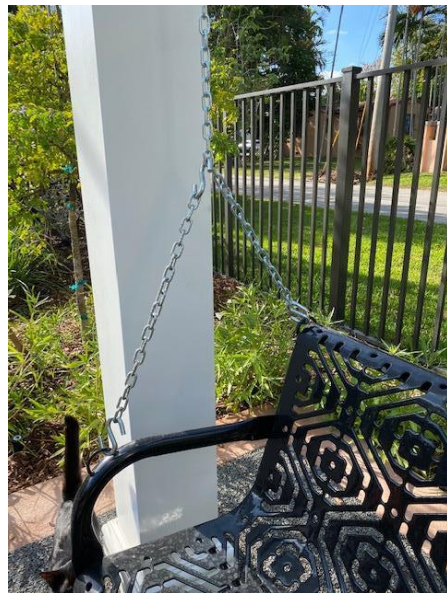
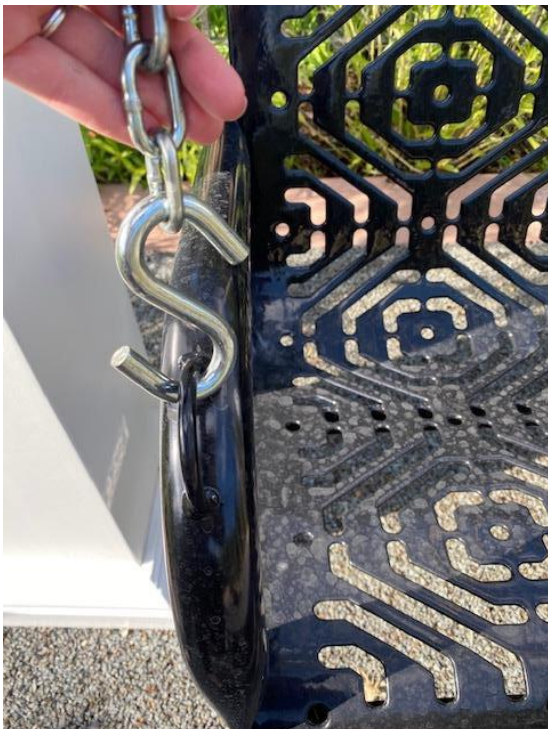
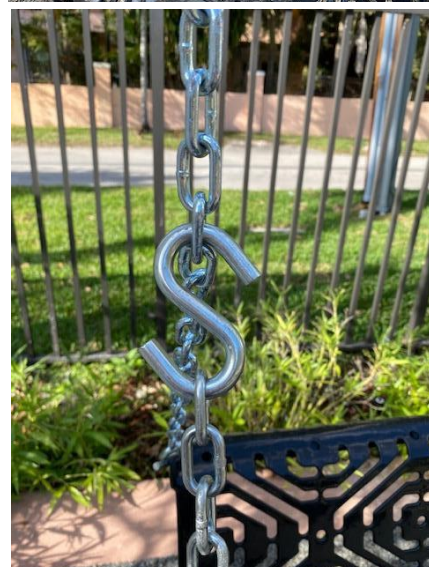
Playground use zones are compliant. Impact attenuation surfacing testing must be provided. Adequate age appropriate rule signage is missing and must be clearly visible to public users. All S-hooks on the arbor bench must be closed for safety to prevent entanglement and crush and shear hazards. See attached images.

Image 3, 4 & 5. All S-hooks on the arbor bench must be closed for safety to prevent entanglement and crush and shear hazards.
